RED BOOKS" of the
BRITISH FIRE PREVENTION COMMITTEE—No. 202.
Edited by the Executive.

A REPORT
ON A
FIRE
AT THE
BON MARCHÉ (ANNEXE)
PARIS
ON
November 22nd, 1915

BY
ELLIS MARSLAND
District Surveyor
General Honorary Secretary.

FROM NOTES SUPPLIED
BY
COLONEL CORDIER
Commandant
Paris Fire Brigade Regiment.

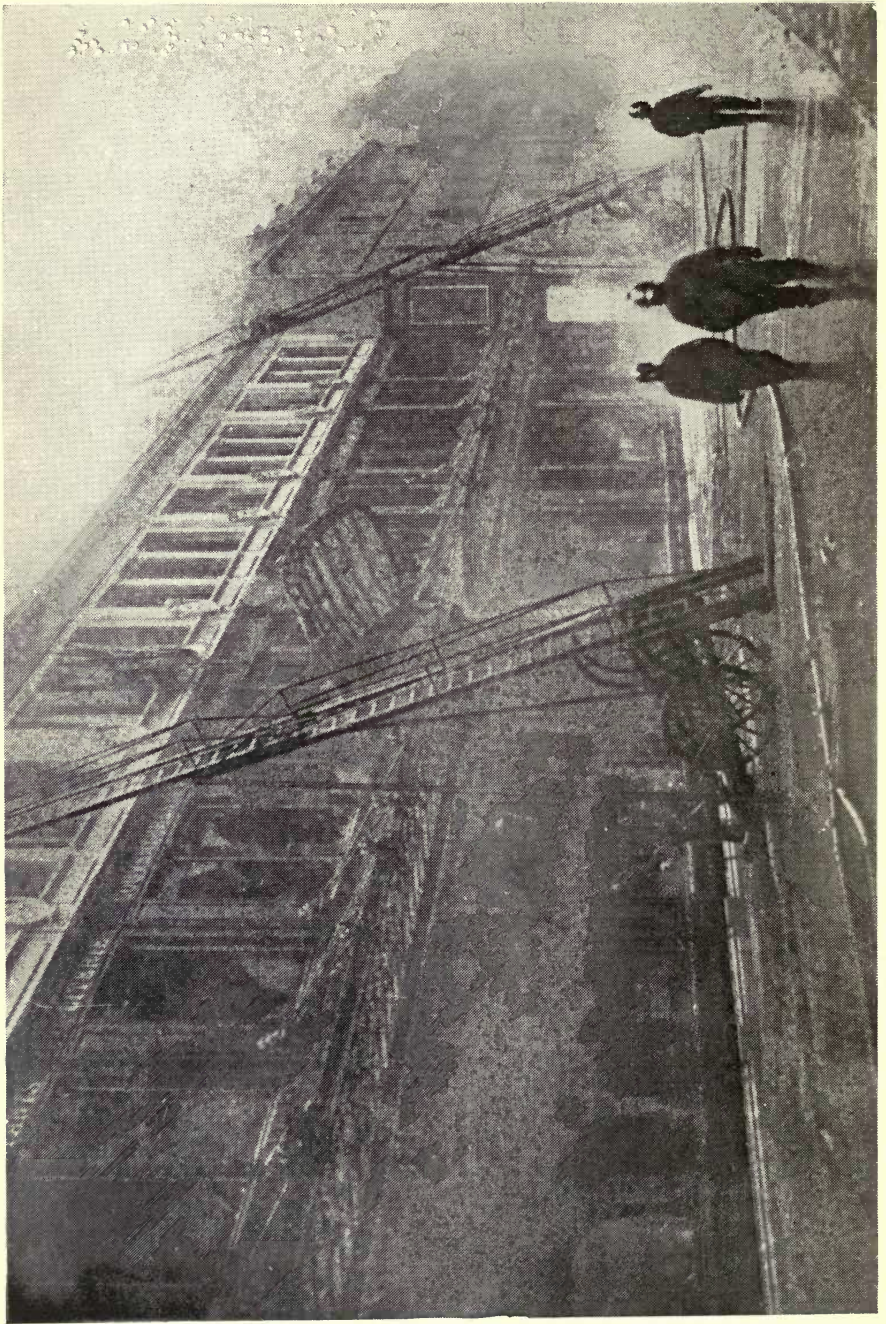
FIG. 1.—GENERAL VIEW TAKEN DURING THE FIRE.

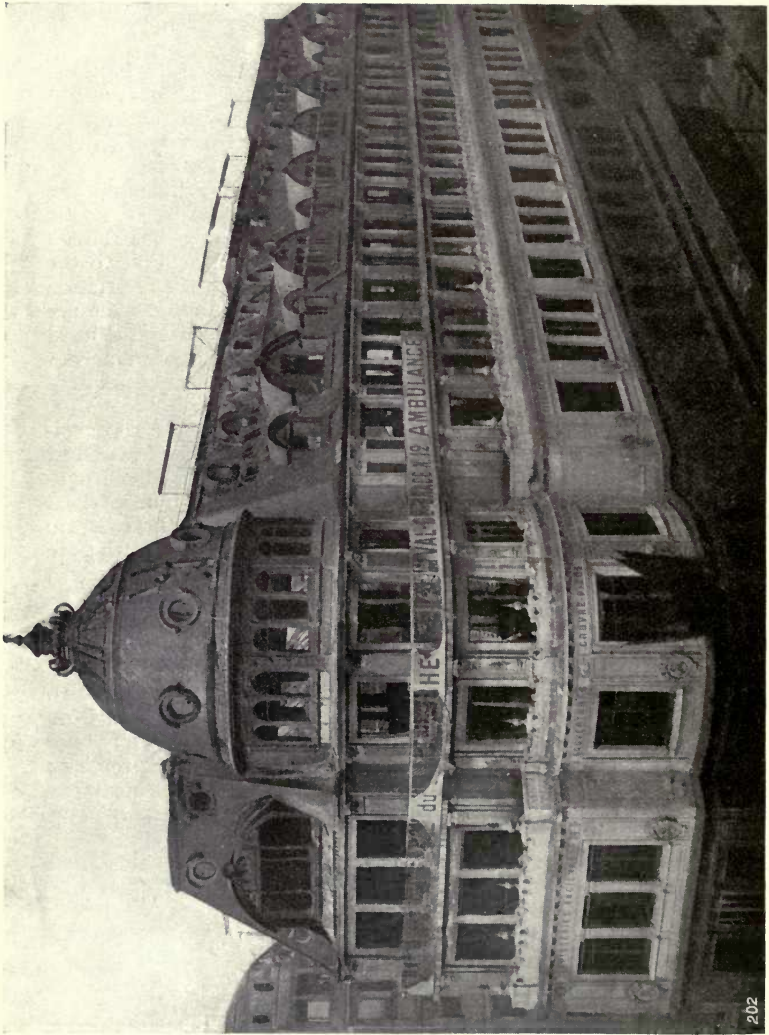
Fig. 2.—View of the Upper Floors of the Façade at the junction of the Rue du Bac and the Rue de Sévres.

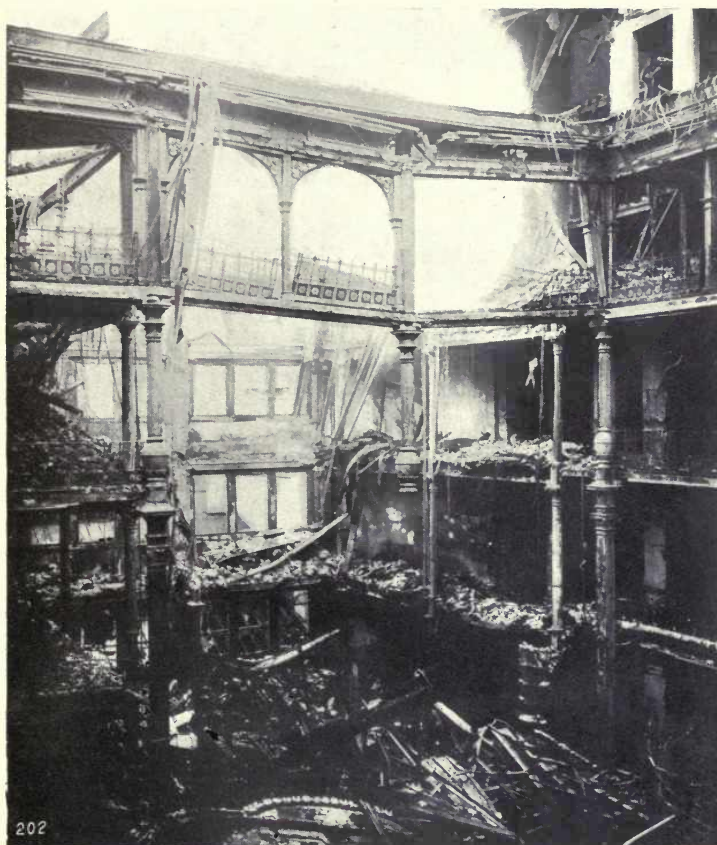
Fig. 3.—View of the interior of the Grand Hall, taken from the principal entrance in the Rue du Bac.

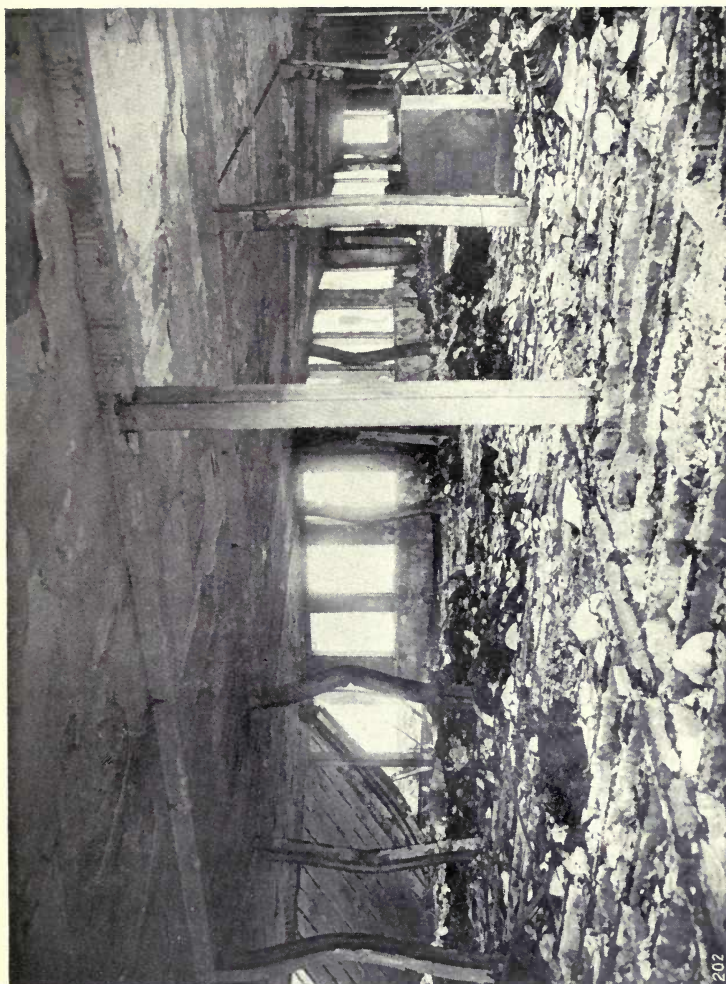
Fig. 4.—View of the Sixth Floor, used for administrative purposes in connection with the Hospital.

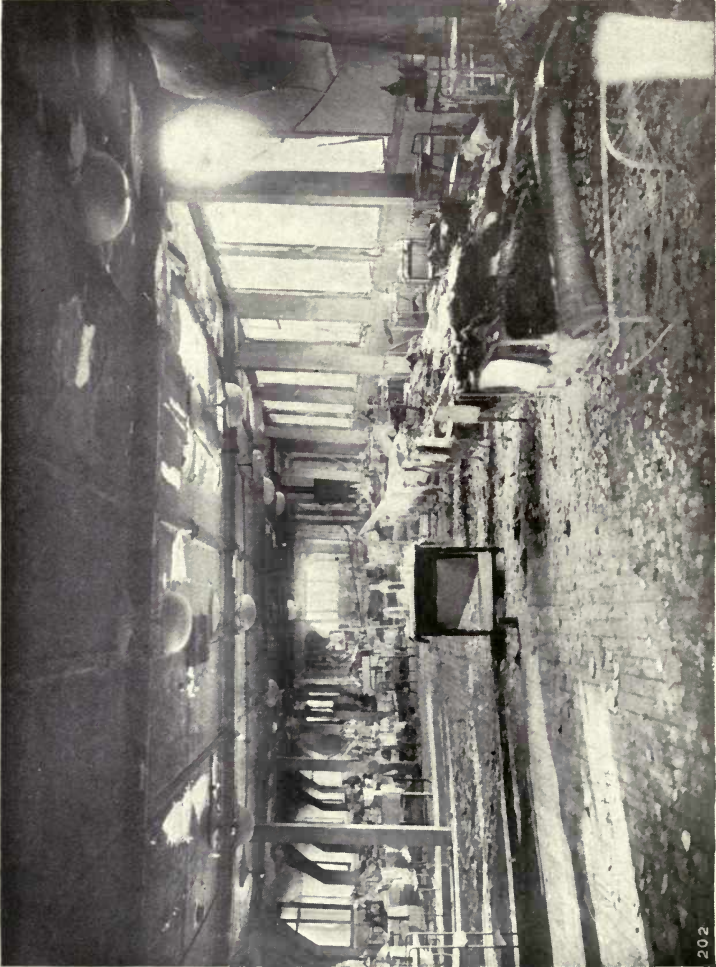
Fig. 5.—View of the Hospital Ward on the Fifth Floor.

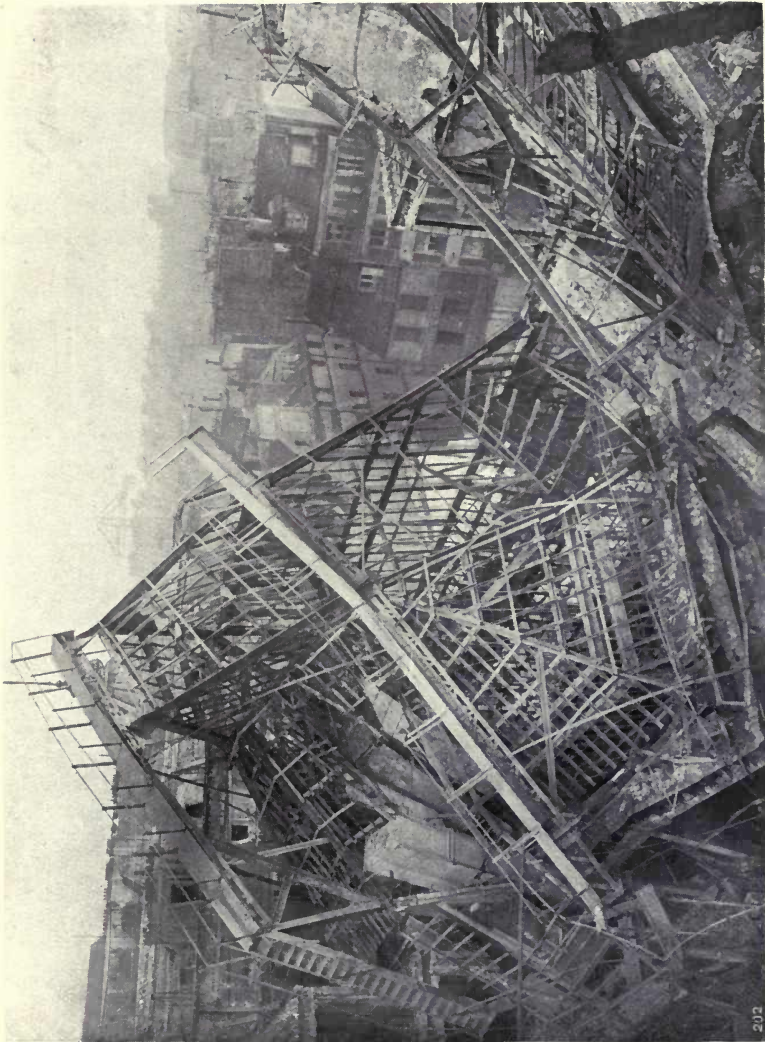
An order was given to the firemen to leave the basements, and almost immediately afterwards the glazed halls and skylights fell in, carrying with them the galleries and some of the floors.

Fig. 6.—View of the wreckage of the roof over the Small Hall.

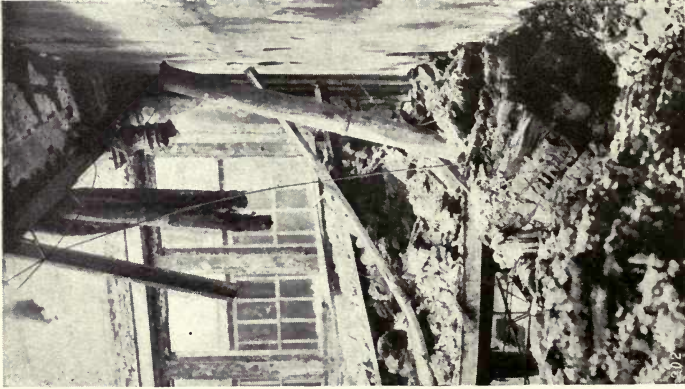
Fig. 8.—View of the interior wreckage.

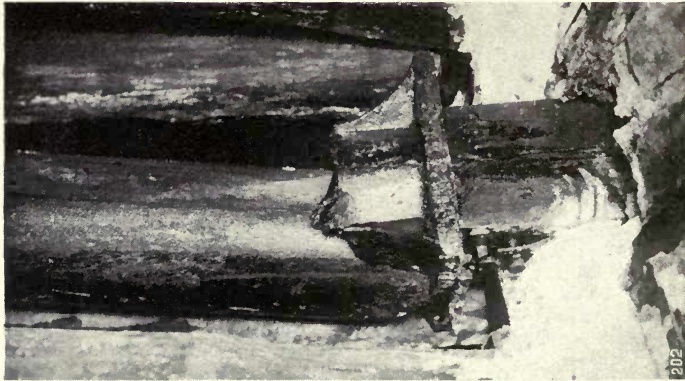
Fig. 7.—Broken column in Basement.

The cast-iron columns on the upper floors were bent and fractured, and in the sub-basement one of them was broken off at the junction of the cap with the shaft (*see Fig. 7*), probably caused by cold water from a jet. It was the failure of this point, producing a vertical settlement of about 0.5 m. (*1 ft. 7½ in.*) in all the floors above, which caused fear of a collapse.

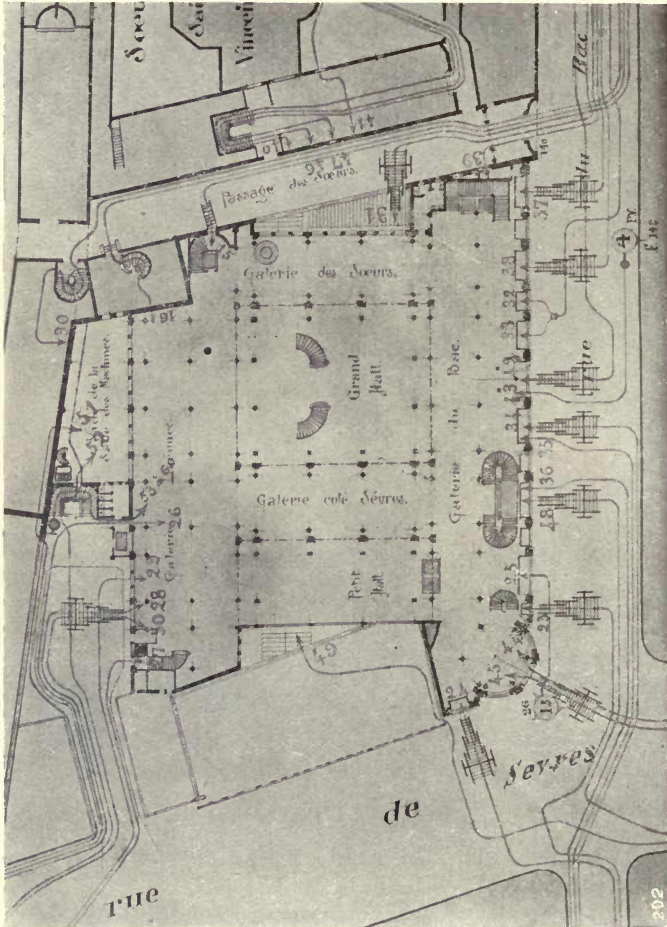
In the interior the floors formed galleries surrounding two central halls, one of which was very large. (*See Fig. 9.*)

Fig. 9.—Plan shewing the Ground Floor of the building and the position of the fire ladders and jets.
(Old Bon Marché building)
